AIRCRAFT AND MAINTENANCE PARTS

NORTH AMERICAN—INSTALLATION OF COTTER PIN IN MAIN LANDING-GEAR
OPERATING STRUT END FITTING—P-51D, P-51K, AND F-6 SERIES

This Technical Order replaces T. O. No. 01-60-102, dated 30 June 1948, revised to delete obsolete models and change effective point of P-51D aircraft.

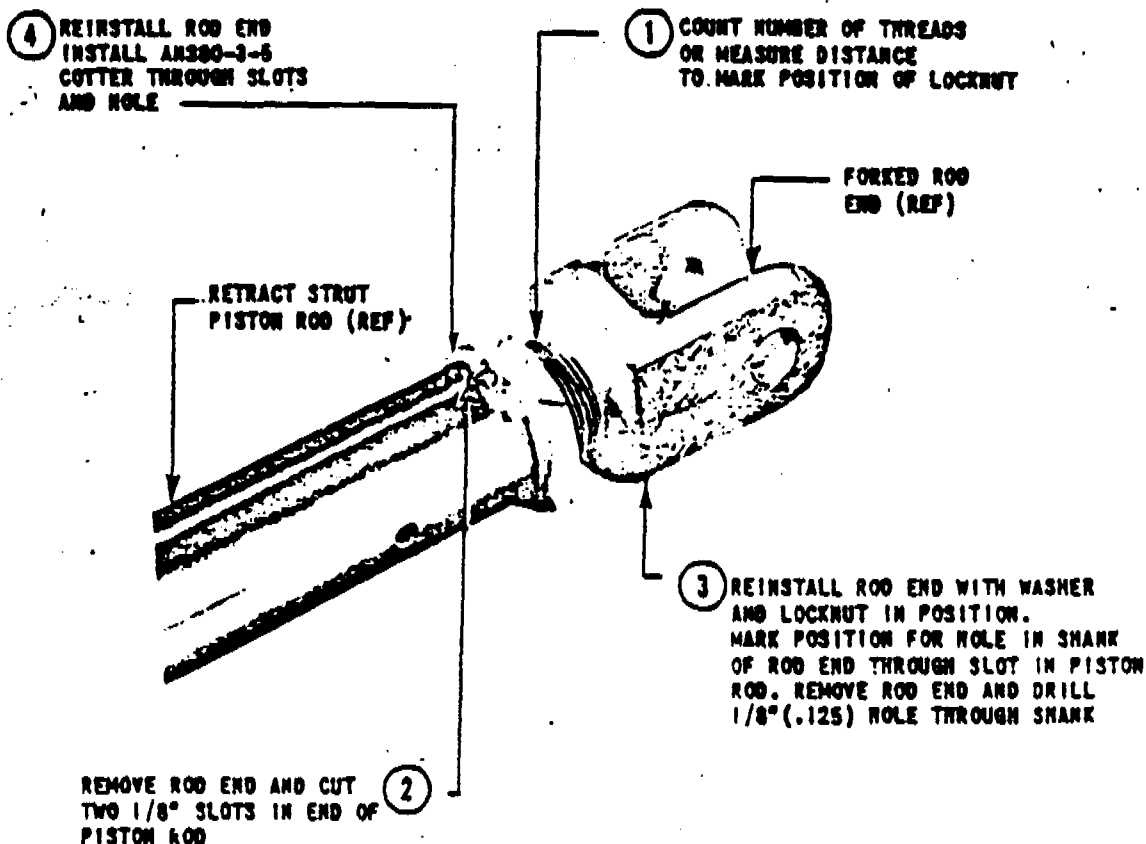
Figure 1 - Rework of Landing-gear Retract Strut

1. To minimize failure of the main landing-gear operating strut and connecting linkage which results when the piston assembly turns on the strut end fitting,

a cotter pin will be installed through the end fitting and piston assembly in accordance with the instructions contained in paragraph 2.

a. (See figure 1.) Locate the piston rod in the retract strut in the aft portion of the wheel well.

c. (See figure 1.) Cut two 1/8-inch square slots, one opposite the other in the outboard end of the piston rod. Clean out all metal chips and filings.

e. Through one of the slots just cut, mark the position for the hole on the threaded shank of the rod end. Use a scribe or other sharp instrument.

f. Remove the forked rod end and drill a 1/8-inch (.125-inch diameter) hole through the shank at the point marked.

g. Discard the washer (if originally installed) and reinstall the rod end in the piston rod. Screw the rod end in until the hole lines up with the slots cut in the piston rod. Install one cotter pin, part No. AN380-3-8.
