AIRCRAFT AND MAINTENANCE PARTS

NORTH AMERICAN—REWORK OF LANDING-GEAR FAIRING DOOR ACTUATING
MECHANISM—P-51D, P-51K, F-6D, AND F-6K

This Technical Order replaces T. O. No. 01-60JE-11, dated 4 September 1944, which directed installation of cable fair-lead.

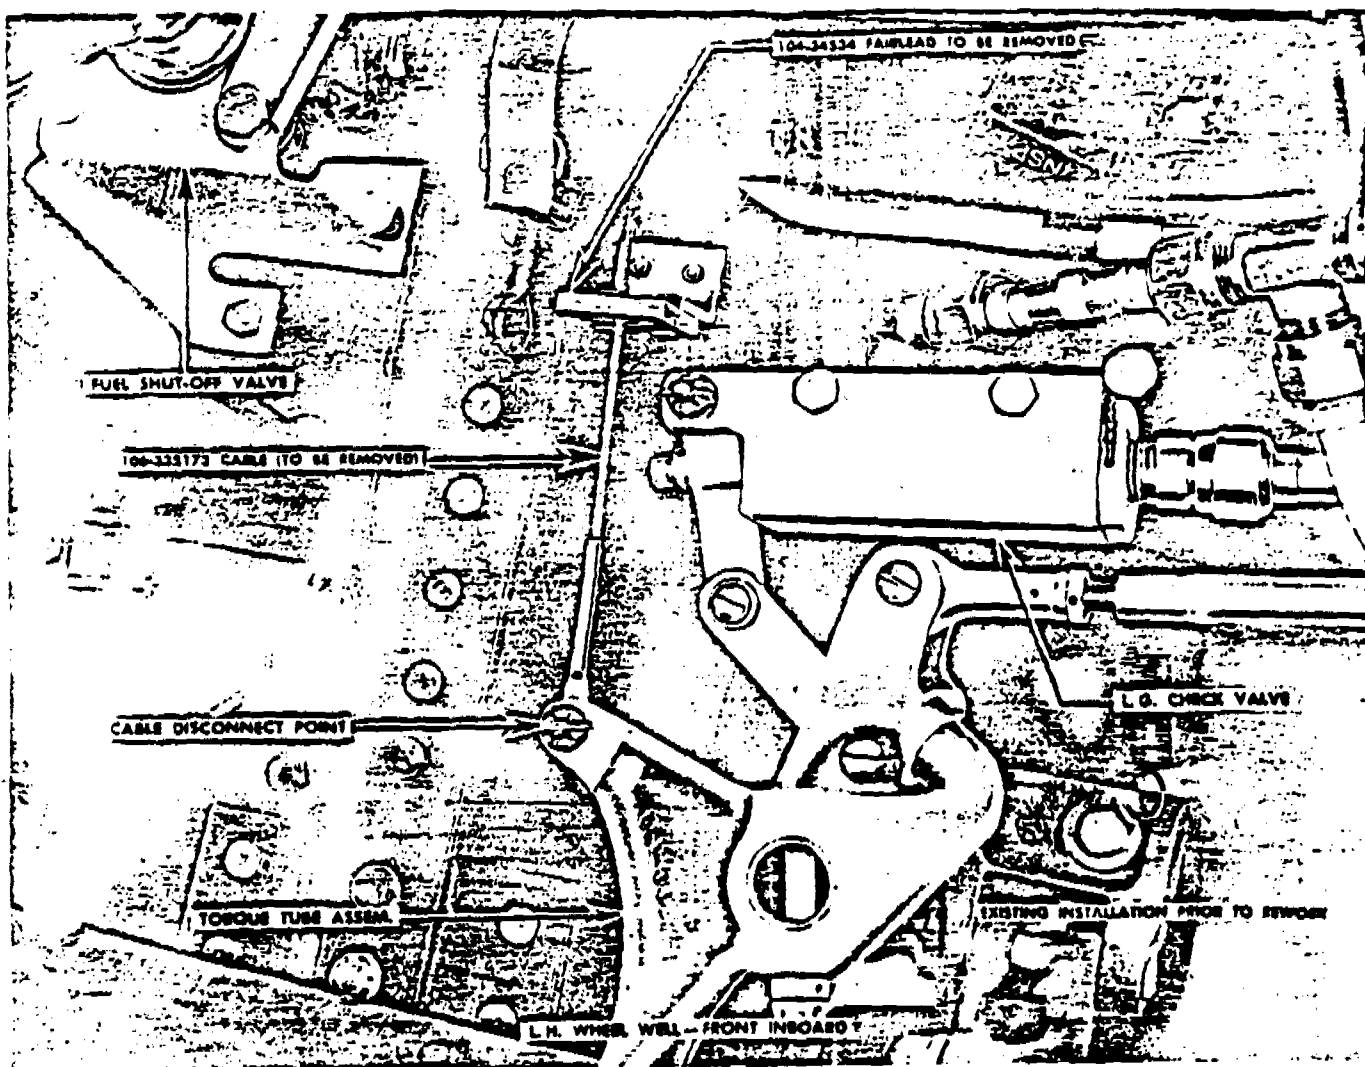
Figure 1 - Existing Cable Installation

1. To prevent the landing-gear fairing door control cable, when slack, from becoming ensnared on the adjacent landing-gear hydraulic check valve which may result in serious malfunctioning of the landing gear, a modification incorporating prerigged landing-gear fairing door control cable will be installed on the following listed airplanes, in accordance with the instructions contained in paragraph 2.

the torque tube assembly and pull through the center rib into the right wheel well. (See figure 1.)

g. Remove the fair-lead, part No. 104-34534 (with 109-33367 clip attached), on station O (center) rib adjacent to the landing-gear check valve, by drilling out the two attaching rivets. Some airplanes will have this fair-lead attached with screws. (See figure 1.)

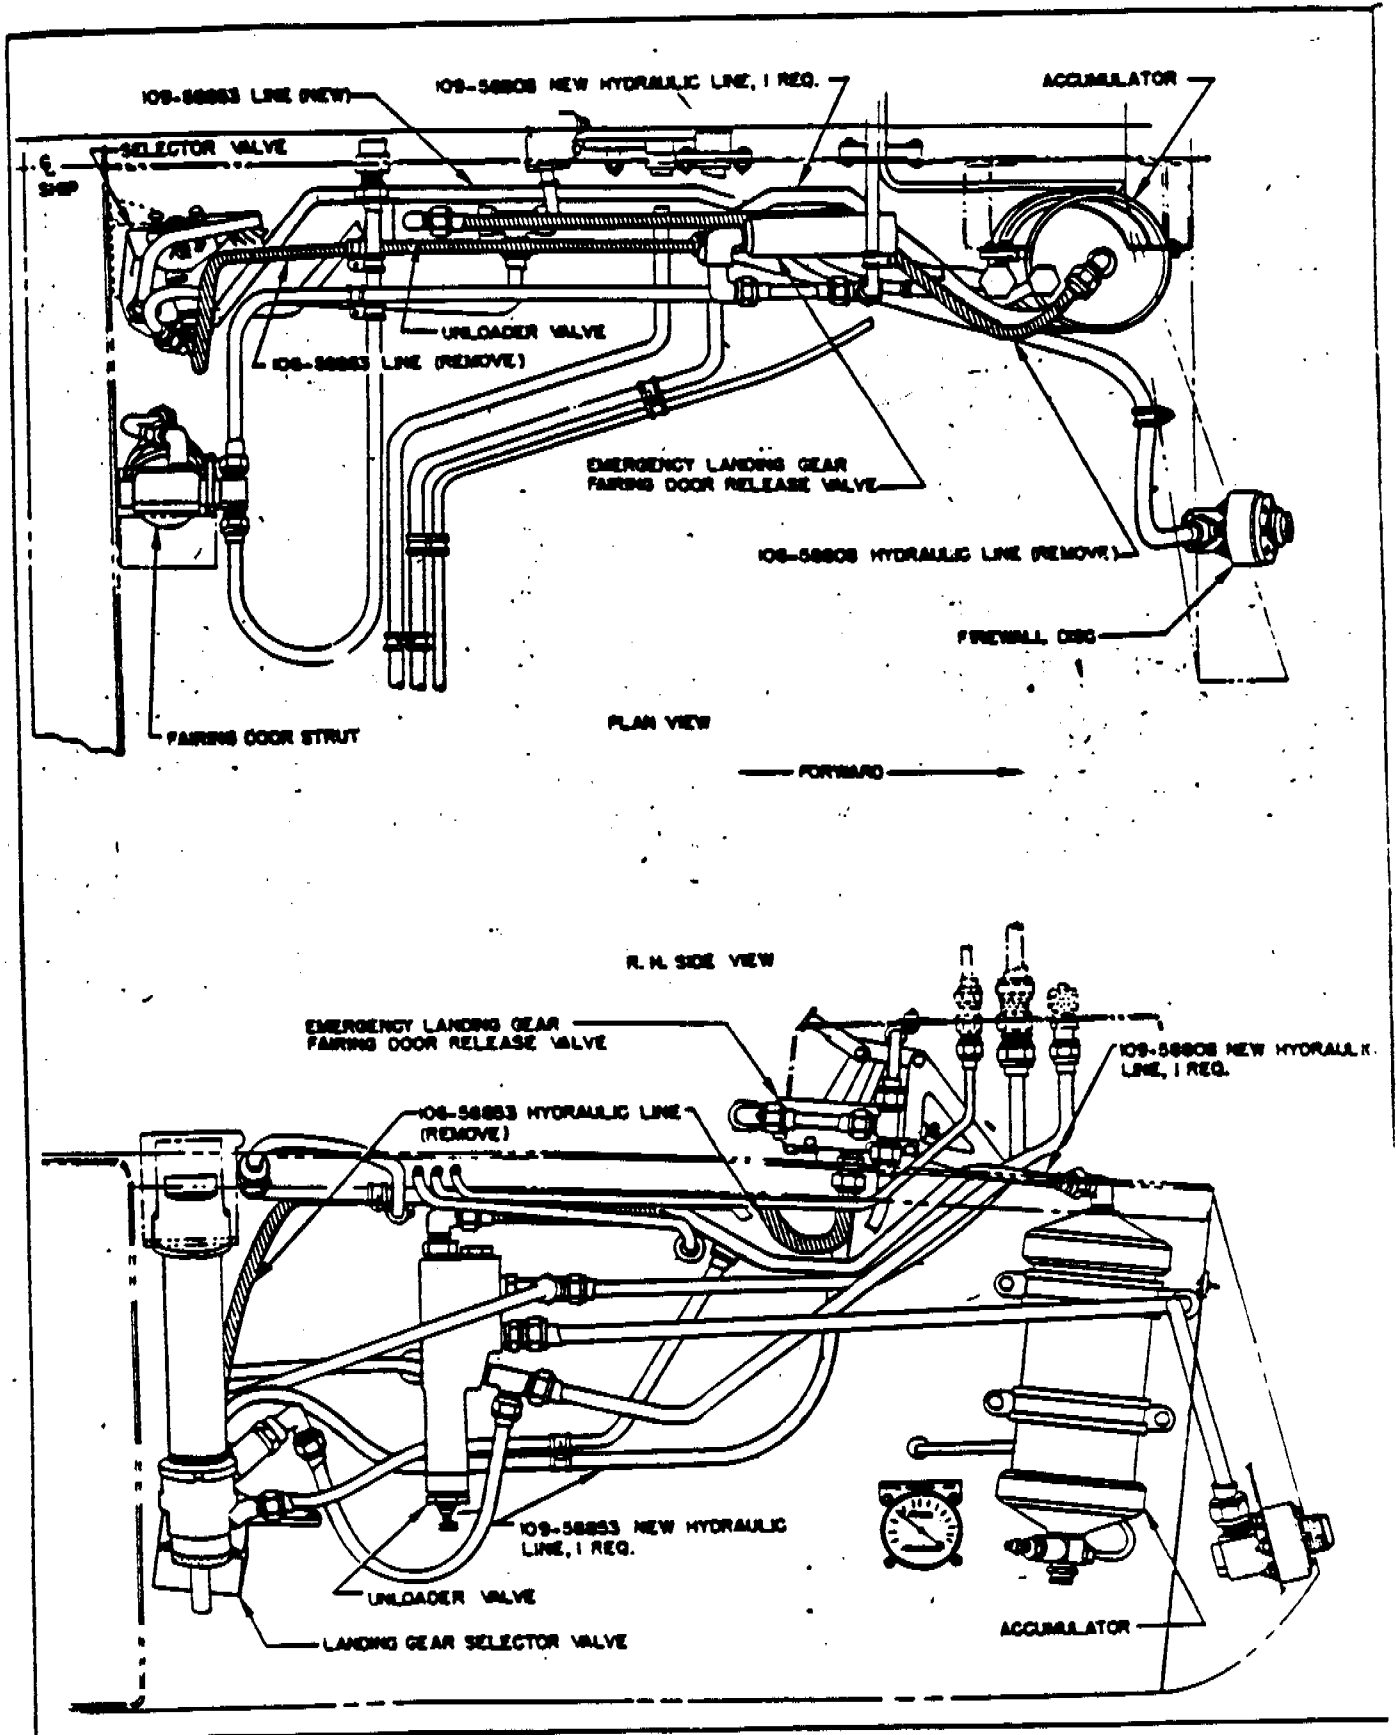
Figure 2 - Replacement of Hydraulic Lines

e. Two hydraulic lines in the right wheel well are to be removed and replaced with new lines to provide clearance for the new bell crank. Disconnect and remove the lines as follows:

(1) Remove the line, part No. 106-58808, routed from the top of the hydraulic accumulator to top of unloader valve. (See figure 2.)

(2) Install the line, part No. 109-58808, by routing from the top of the hydraulic accumulator to the top of the unloader valve. (See figure 2.)

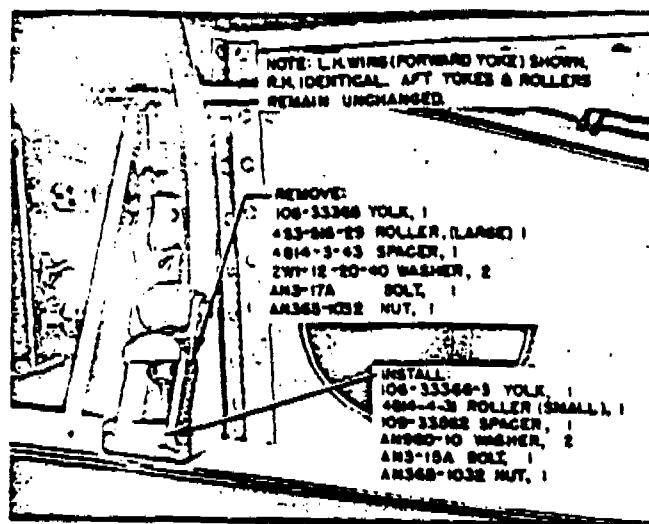
Figure 7 - Replacement of Yokes and Rollers

NOTE The replacement of the forward yokes and rollers on the preceding airplanes is necessary to provide clearance between the yoke and the door skin and preclude the possibility of malfunctioning of the door locks. The aft rollers and yokes which are the same as the forward ones will not require rework. Refer to figure 7 in conjunction with the following instructions which apply to both left and right wheel wells.

(a) Locate the forward door lock yoke at sta 83.5 rib in the wing leading edge, just outboard of gun camera. (See figure 7.)

(c) As shown in figure 7, assemble a new yoke and roller assembly consisting of a new yoke, spacer, roller, bolt, washers, and the nut removed from the horizontal roller.
