February 12, 1944

AIRPLANES AND MAINTENANCE PARTS

**NORTH AMERICAN—REWORK OF TAIL WHEEL IDLER CAMSHAFT
DECLUTCHING CABLE—P-51A AND P-51C**

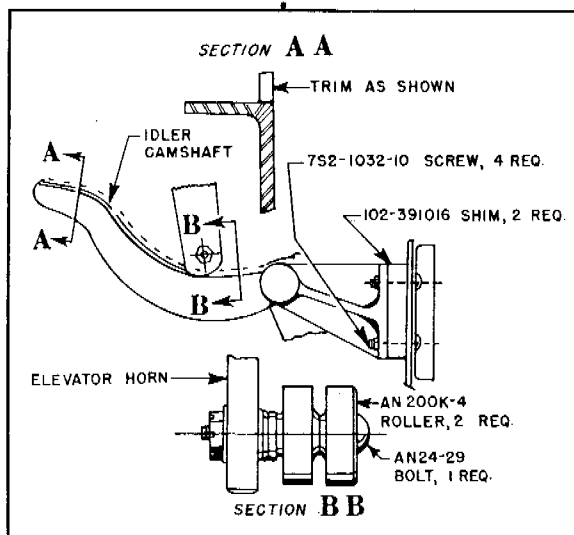
Figure 1 - View Showing Roller Added and Flange To Be Removed From Idler Camshaft

1. To prevent the possibility of the elevator controls becoming jammed due to the elevator horn assembly slipping off the declutching camshaft assembly the P-51 airplanes listed below will be reworked in accordance with the instructions contained in paragraph 2.

(4) File or grind the upper vertical flange off the camshaft. (See figure 1, detail AA.)

(5) Remove the bolt which secures the ball-bearing roller to the horn assembly. (This roller rides on camshaft.) Add one new roller, part No. AN200K-4, to the present assembly and secure with one new bolt, part No. AN24-29, using the same nut and washer removed. (See figure 1, detail BB.)

(6) Reinstall the two supporting brackets, inserting one each new block, part No. 102-341016, to act as a shim between each bracket and the fuselage frame. Secure with four new screws, part No. 7S2-1032-18, using the same nuts previously removed. (See figure 1.)
