AIRCRAFT AND MAINTENANCE PARTS

NORTH AMERICAN—REWORK OF LANDING-GEAR FAIRING DOOR ACTUATING
MECHANISM—P-51D, P-51K, F-6D, AND F-6K

This Technical Order replaces T. O. No. 01-60JE-11, dated 4 September 1944, which directed installation of cable fair-lead.

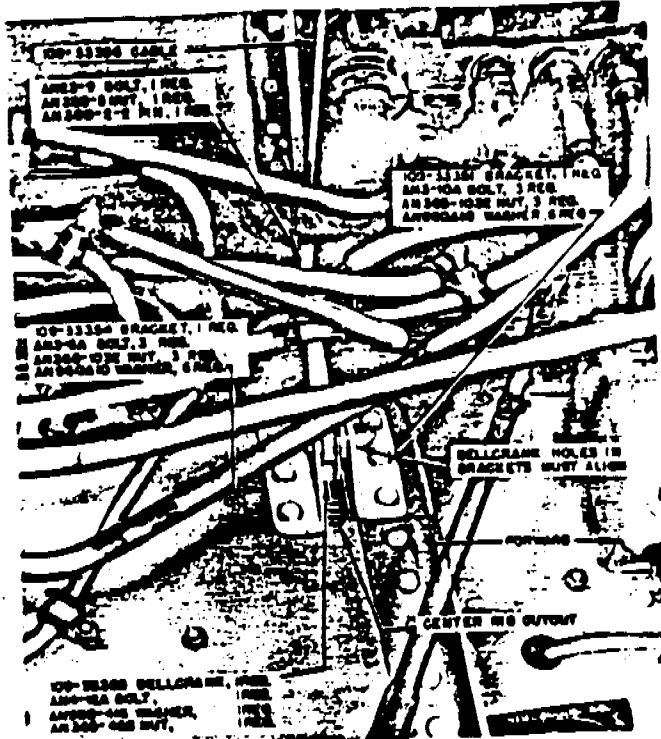
Figure 5 - Bell Crank - Right Wheel Well

1. To prevent the landing-gear fairing door control cable, when slack, from becoming ensnared on the adjacent landing-gear hydraulic check valve which may result in serious malfunctioning of the landing gear, a modification incorporating prerigged landing-gear fairing door control cable will be installed on the following listed airplanes, in accordance with the instructions contained in paragraph 2.

(2) Install the bell crank, part No. 109-33353, and aft bracket, part No. 109-33354, by securing to the forward bracket as shown in figure 5.

(4) Secure the aft bracket with the attaching parts as shown in figure 5.

(f) Install the cable, part No. 109-33556, by connecting it to the bell crank on the center rib with the attaching parts as shown in figure 5.
